# Trinsic Tub/Shower Trim Garniture pour Bain/Douche Trinsic

Models/Modelos/Modèles T14059, T14259 & T14459 Series/Series/Seria

T14059, T14259, T14459 51975 Rev. K 8-21-12

## Cartridge Summary Reference Sheet

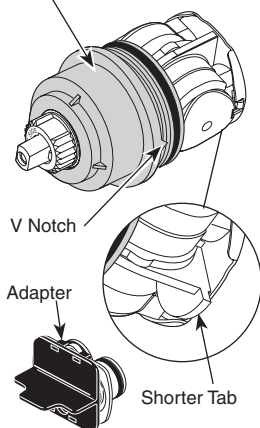
17

Grey Upper Cap

Order RP46463 to Replace Cartridge.

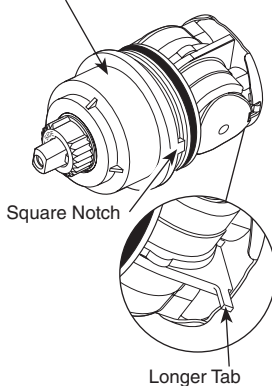
1700

White Upper Cap

Order RP32104 to Replace Cartridge.
