## Gem•2® Flushometer

### TAILPIECES, CONTROL STOPS AND FLUSH CONNECTIONS

#### PARTS LIST

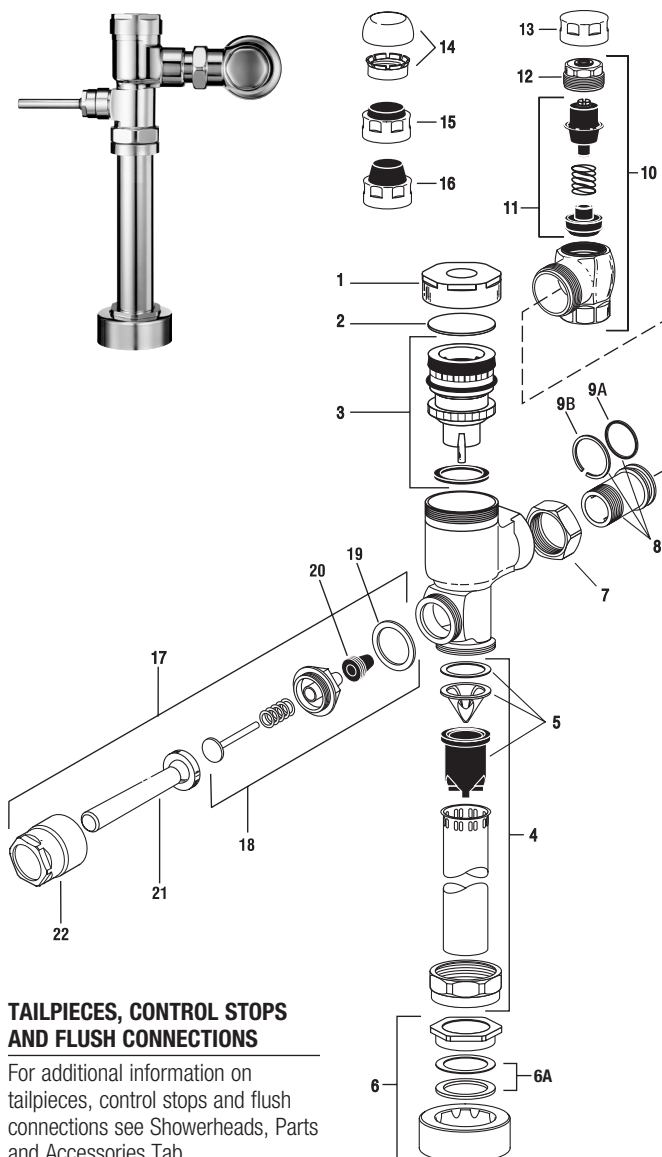
Item No.	Code No.	Part No.	Description
1.	<b>0307142</b>	G-105	CP Cover
2.	<b>0307139</b>	G-106	Slip Disc
3.	<b>3307135</b>	G-1022-A	Piston Kit – 1.28 gpf/4.8 Lpf Water Closet
	<b>0307193</b>	G-1007-A	Piston Kit – 3.5 gpf/13.2 Lpf Water Closet
	<b>0307195</b>	G-1016-A	Piston Kit – 1.6 gpf/6 Lpf Water Closet
	<b>0307192</b>	G-1009-A	Piston Kit – 1.5 gpf/5.7 Lpf Urinal
	<b>0307185</b>	G-1017-A	Piston Kit – 1.0 gpf/3.8 Lpf Urinal
	<b>3307133</b>	G-1018-A	Piston Kit – 0.5 gpf/1.9 Lpf Urinal
	<b>3307134</b>	G-1019-A	Piston Kit – 2.4 gpf/9.0 Lpf Water Closet
	<b>3307136</b>	G-1023-A	Piston Kit – 0.125 gpf/0.5 Lpf Urinal
	<b>3307137</b>	G-1024-A	Piston Kit – 0.25 gpf/1.0 Lpf Urinal

4.	<b>5323005</b>	V-500-AA	3/4" x 9" Vacuum Breaker – 6 per package
	<b>5323006</b>	V-500-AA	1-1/4" x 9" Vacuum Breaker – 6 per package
	<b>5323007</b>	V-500-AA	1-1/2" x 9" Vacuum Breaker – 6 per package

5.	<b>3323192</b>	V-551-A	Vacuum Breaker Repair Kit
6.	<b>3332002</b>	CR-1010-A	1-1/2" (38 mm) Spud Coupling
	<b>3332001</b>	CR-1009-A	1-1/4" (32 mm) Spud Coupling
	<b>3332000</b>	CR-1008-A	3/4" (19 mm) Spud Coupling
6A.	<b>SEE SLIP JOINT GASKETS AND RINGS TABLE BELOW LEFT</b>

7.	<b>0308676</b>	H-550	Stop Coupling
8.	<b>0308801</b>	H-551-A	Adjustable Tailpiece 2-1/16" (Standard Length)
9A.	<b>5308696</b>	H-553	O-ring – 24 per package
9B.	<b>5308381</b>	H-552	Locking ring – 12 per package

10.	<b>0388022</b>	H-710-A	1" Screwdriver Bak-Chek® Stop CP – complete
	<b>0388025</b>	H-710-A	3/4" Screwdriver Bak-Chek® Stop CP – complete
11.	<b>3308853</b>	H-541-A	Control Stop Repair Kit*
	<b>3308856</b>	H-543-A	Control Stop Repair Kit**

12.	<b>0308612</b>	H-622	CP Bonnet*
	<b>0308843</b>	H-577	CP Bonnet** – <b>OBSOLETE</b>
13.	<b>3308840</b>	H-573-A	Control Stop Cap CP*
	<b>0308848</b>	H-582	Control Stop Cap CP**

14.	<b>3308791</b>	H-1010-A	Vandal Resistant Control Stop Cap Assembly*
	<b>3308790</b>	H-1009-A	Vandal Resistant Control Stop Cap Assembly**
15.	<b>3308866</b>	H-574	Control Stop Cap w/Bumper (-YO Variation)*

16.	<b>3308867</b>	H-576	Control Stop Cap w/Extended Bumper (-YG Variation)*
17.	<b>3388017</b>	H-1017	Flow Control (HEU Only) (Not Shown)

17.	<b>0307100</b>	G-143	Handle Assembly
18.	<b>5307074</b>	G-50-A	Handle Repair Kit – 6 per package
19.	<b>5307065</b>	G-35	Handle Gasket – 48 per package
20.	<b>5302297</b>	B-39	Handle Seal – 12 per package
21.	<b>0307024</b>	G-145	Handle Grip
22.	<b>0307020</b>	G-144	Handle Socket

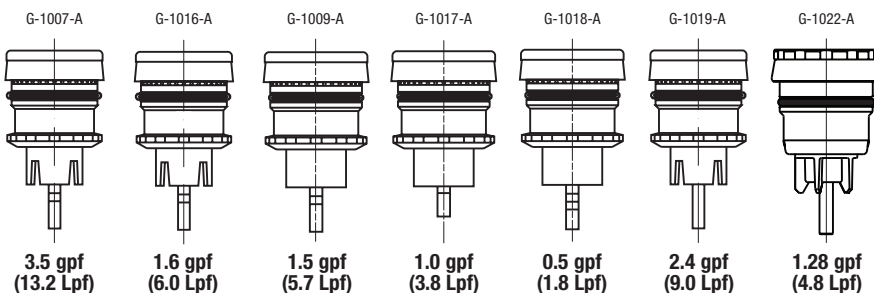
Gem•2 Pistons can be identified by the color, shape and marking of the above components.

Code No.	Part No.	Description	Cover Color	Piston Color	Barrel	Grooves
<b>0307193</b>	G-1007-A	3.5 gpf (13.2 Lpf) – Water Closet	White	Gray	Slotted	2
<b>0307195</b>	G-1016-A	1.6 gpf (6.0 Lpf) – Water Closet	Green	Black	Slotted	2*
<b>0307192</b>	G-1009-A	1.5 gpf (5.7 Lpf) – Urinal	Black	Black	Solid	2
<b>0307185</b>	G-1017-A	1.0 gpf (3.8 Lpf) – Urinal	Yellow	Black	Solid	1
<b>3307133</b>	G-1018-A	0.5 gpf (1.8 Lpf) – Urinal	Red	Black	Solid	3
<b>3307134</b>	G-1019-A	2.4 gpf (9.0 Lpf) – Water Closet	Blue	Gray	Slotted	0
<b>3307135</b>	G-1022-A	1.28 gpf (4.8 Lpf) – Water Closet	Deep Purple	Black	Slotted	0

\*Prior to February 2006-1 Groove

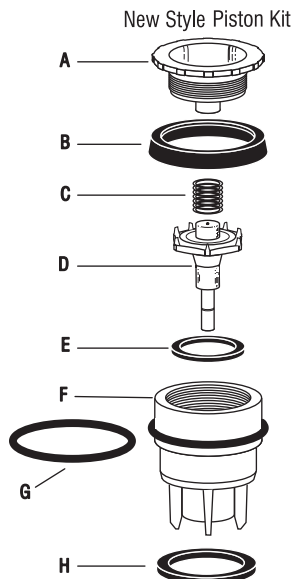
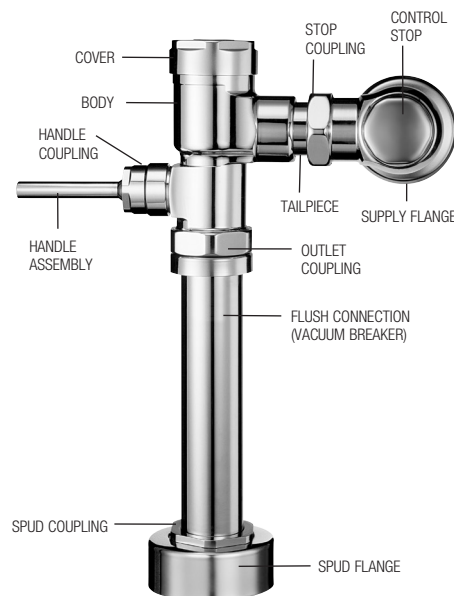
Item	Code No.	Part No.	Description
A.	***	***	Piston Cover
B.	<b>5307106</b>	G-78	Molded Cup – 12 per package
C.	<b>0307130</b>	G-102	Spring
D.	***	***	Relief Valve
E.	<b>0307116</b>	G-95	Relief Valve Seat
F.	***	***	Piston Body
G.	<b>0307210</b>	G-85	Filter O-ring
H.	<b>5307052</b>	G-21	Main Seat – 6 per package

Code No.	Part No.	Description
<b>3307128</b>	G-1011-A	Repair Kit includes Items: 2, 6, 7, B, C, E, G & H

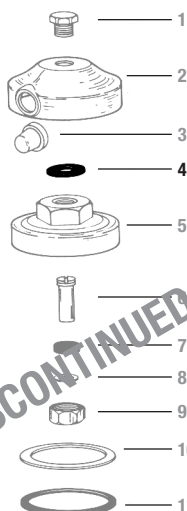
### REPAIR PARTS FOR OLD STYLE GEM FLUSHOMETERS (PRE-1985) Adjustable Cover

Item No.	Code No.	Part No.	Description
1.	—	G-24	CP Cover Screw – <b>OBSOLETE</b>
2.	—	G-23	CP Cover – <b>OBSOLETE</b>
	—	G-26	CP Cover for Bumper – <b>OBSOLETE</b>
3.	—	G-27	Bumper (12 per package) – <b>OBSOLETE</b>
4.	<b>0307058</b>	G-25	Cover Gasket (12 per package)
5.	—	G-4	RB Inside Cover – <b>OBSOLETE</b>
6.	—	G-6	RB Regular Screw – <b>OBSOLETE</b>
7.	—	S-26	Packing
8.	—	S-24	Packing Disc
9.	—	G-10	RB Packing Nut – <b>OBSOLETE</b>
10.	—	G-65	Gasket – <b>OBSOLETE</b>
11.	—	G-5	Gasket
